HISTORIC STRUCTURES REPORT  
SAN FRANCISCO CITY HALL

Prepared for  
CITY & COUNTY OF SAN FRANCISCO  
DEPARTMENT OF PUBLIC WORKS  
BUREAU OF ARCHITECTURE

July 12, 1993

CAREY & CO.  
ARCHITECTURE

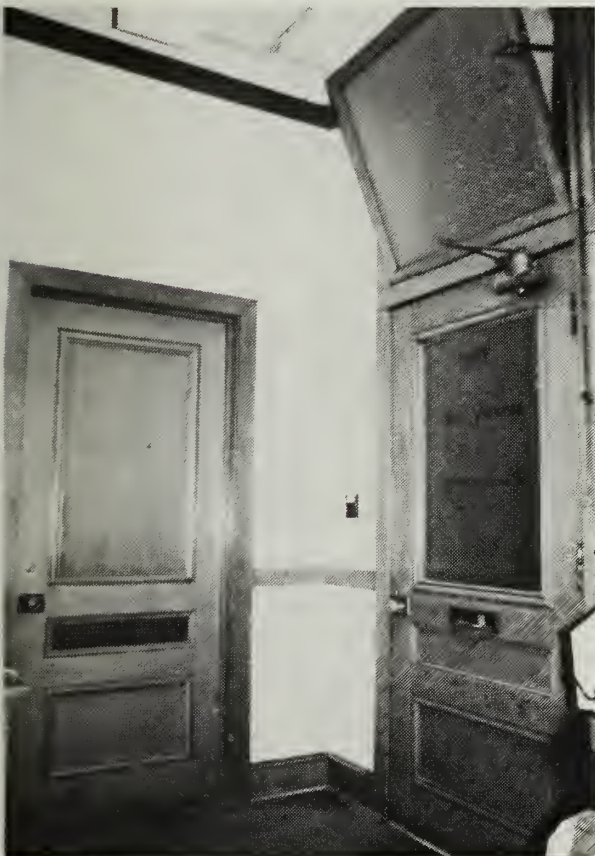
Figure 18 - Typical office doors

The most common door type is the three-panel wood door (see figures 18 and 19). These are found throughout the building in offices and corridors. The panels are solid or a combination of grilles and glazing.

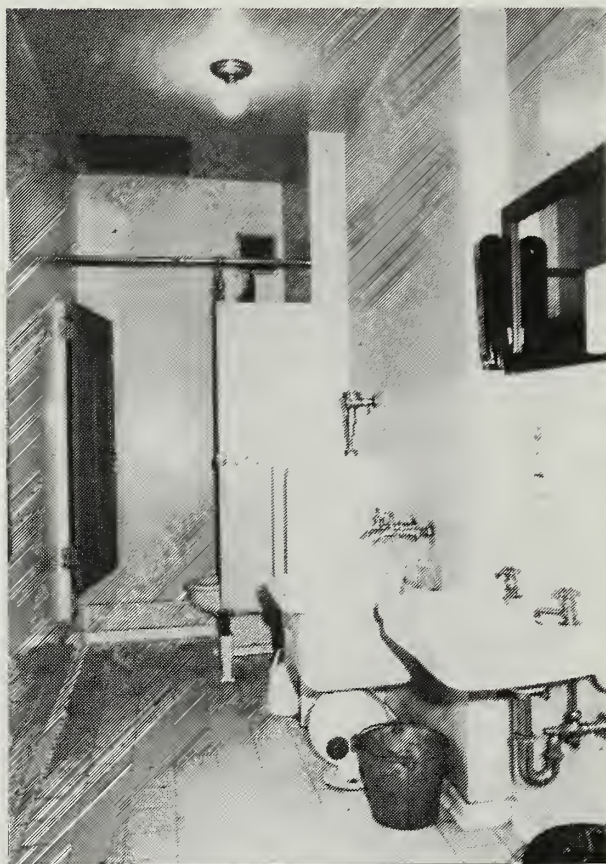
Figure 20 - Attic toilet room

Hardware on the doors to the Mayor's Office and Council Chamber is also bronze, but is larger and more decorative. Nickel-plated bronze hardware is located on the doors to utility spaces like janitor closets and toilet rooms (see figure 20). Most original hardware is in good condition.

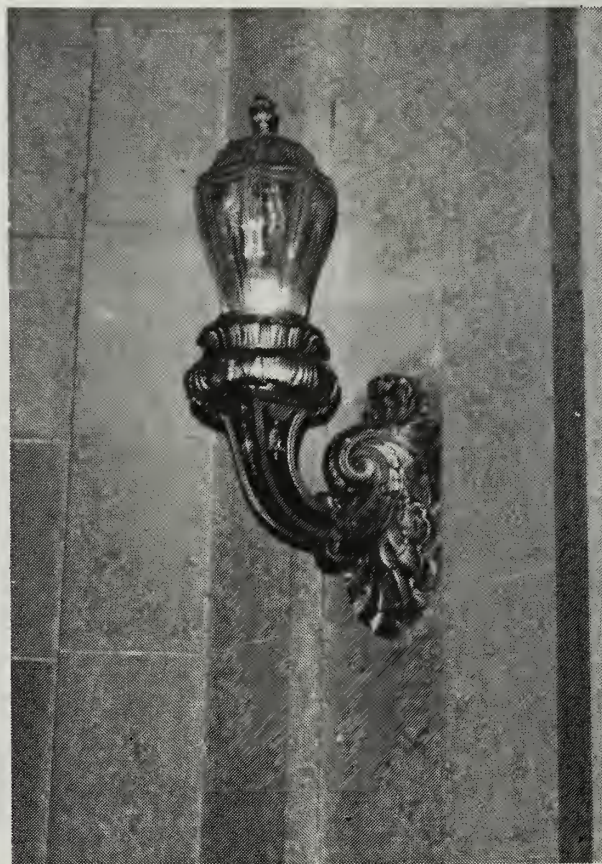
Figure 21 - Sconce at elevator lobby

Original light fixtures remain in City Hall, including the ornate freestanding luminaires in the rotunda, ceiling mounted and suspended incandescent fixtures, and ornamental wall sconces. Ornate glass globes cover the fixtures in the primary public spaces (see figure 21). Fixtures in closets and other utilitarian spaces have globes with a simpler pattern.

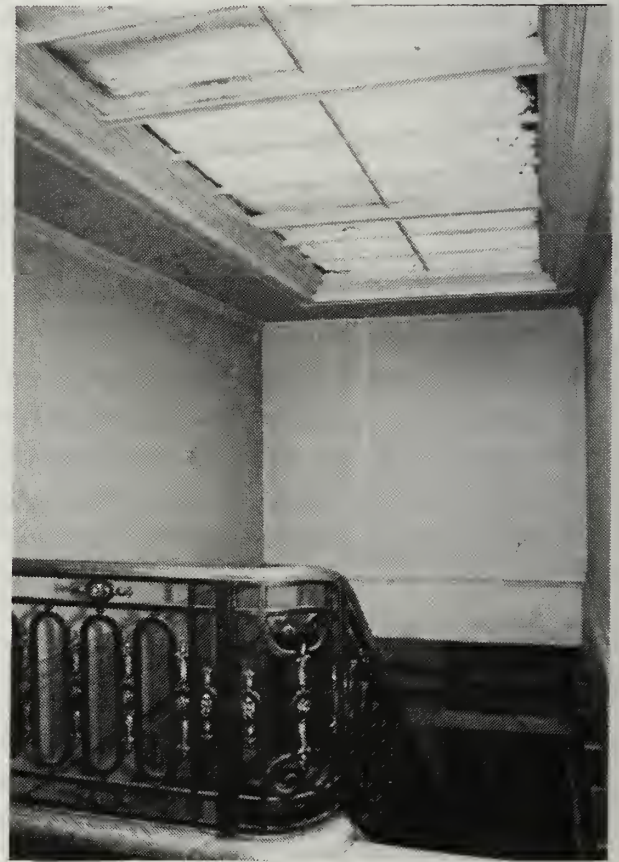
Figure 23 - Skylight at top of main stair

The stairs are illuminated primarily by the suspended luminaires of the adjacent corridor. An ornate, single-globe wall sconce at the first floor, and skylights at the attic level provide supplemental light (see figure 23).

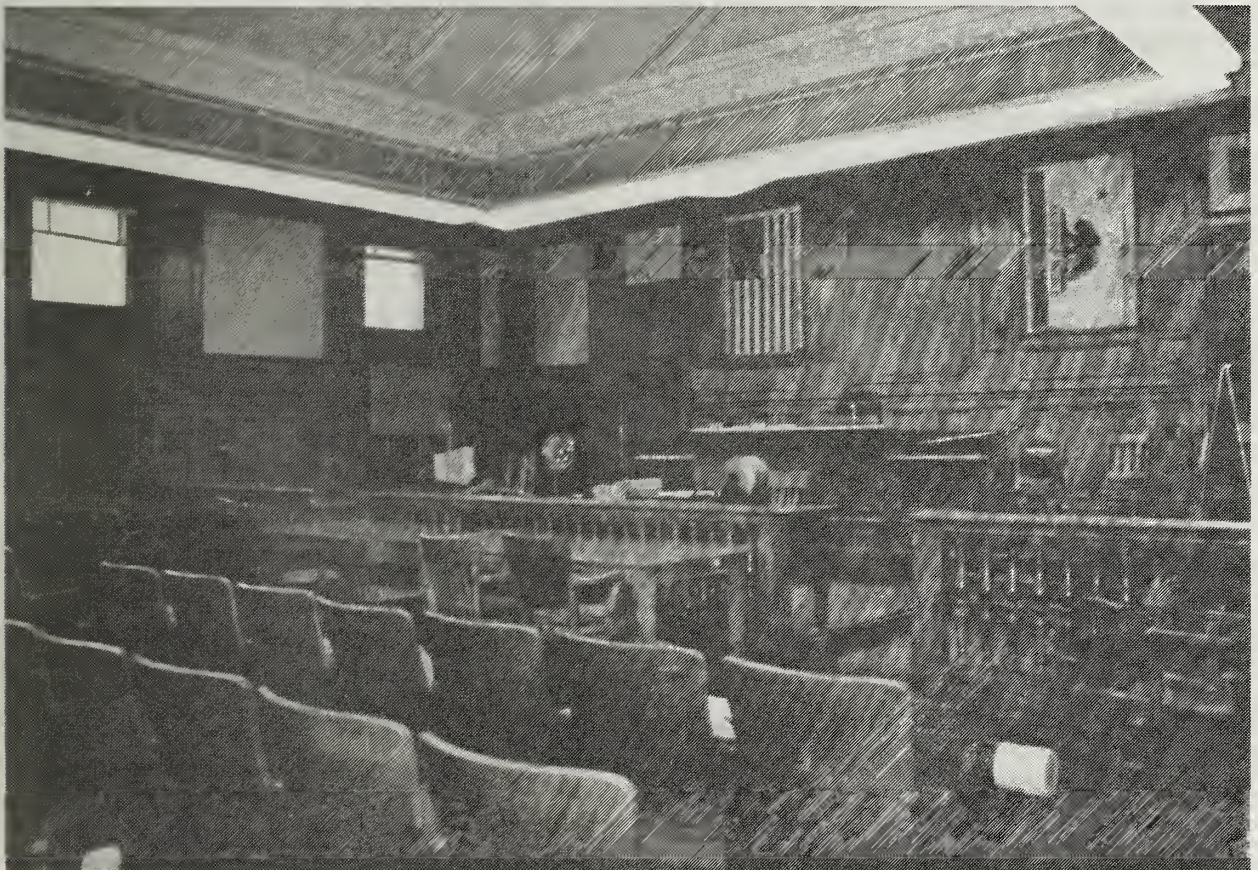
Figure 24 - Fourth floor Supervisor Courtroom

A single large recess covers the entire center of the ceiling. The recess consist of wood, plaster painted to imitate wood, and flat plaster. The flat plaster is often covered with acoustical tile. Superior courtroom A432 contains a tripartite recess which has been covered by a furred-down, acoustical tile ceiling (see figure 24).

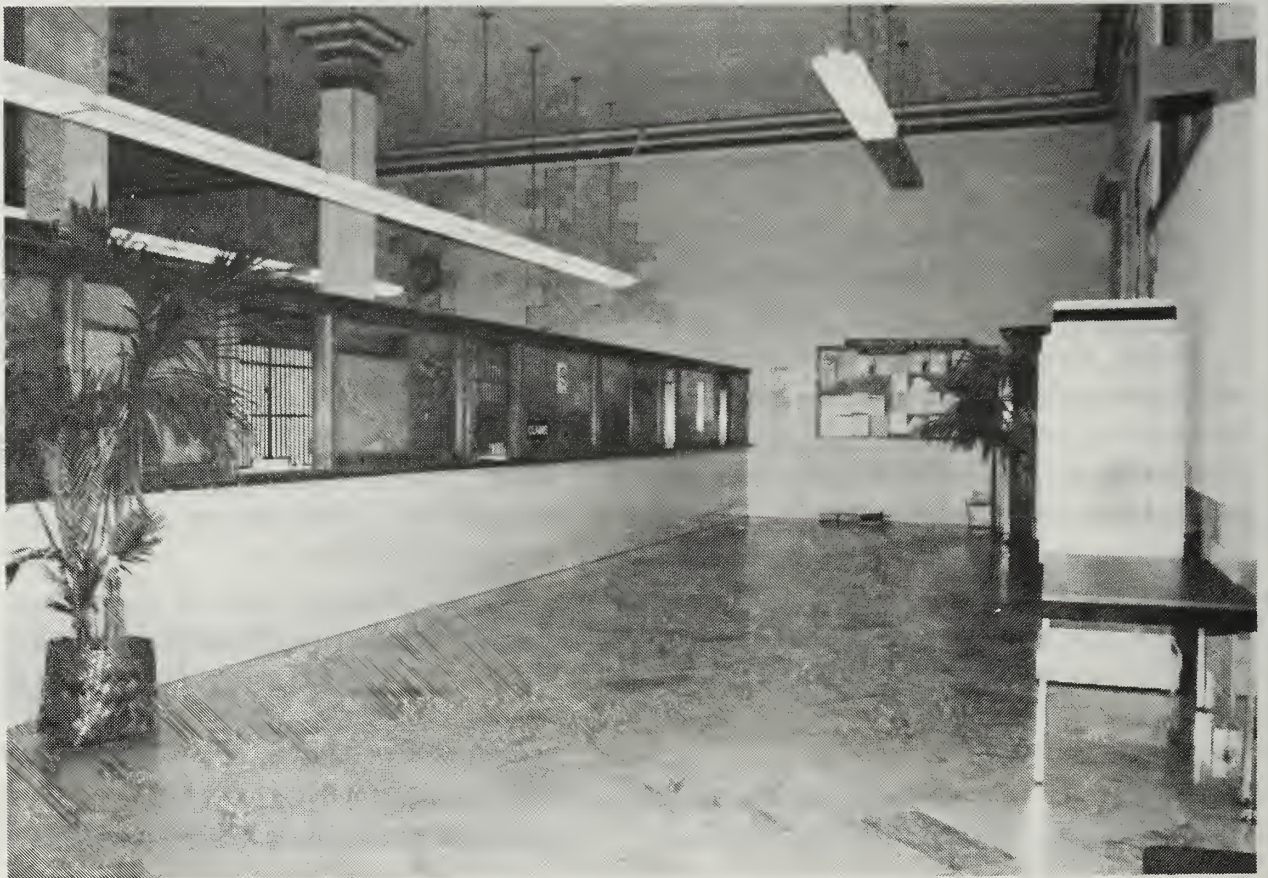
Figure 26 - Controller's Lobby

The configuration of the public space in this department is the most significant alteration (see figure 26). A book vault in the southern portion of the open plan office was removed. Also, a non-original stairway to a basement restroom is centrally located in the western portion of the space. There is extensive plaster damage to all walls of this room, particularly the north wall.

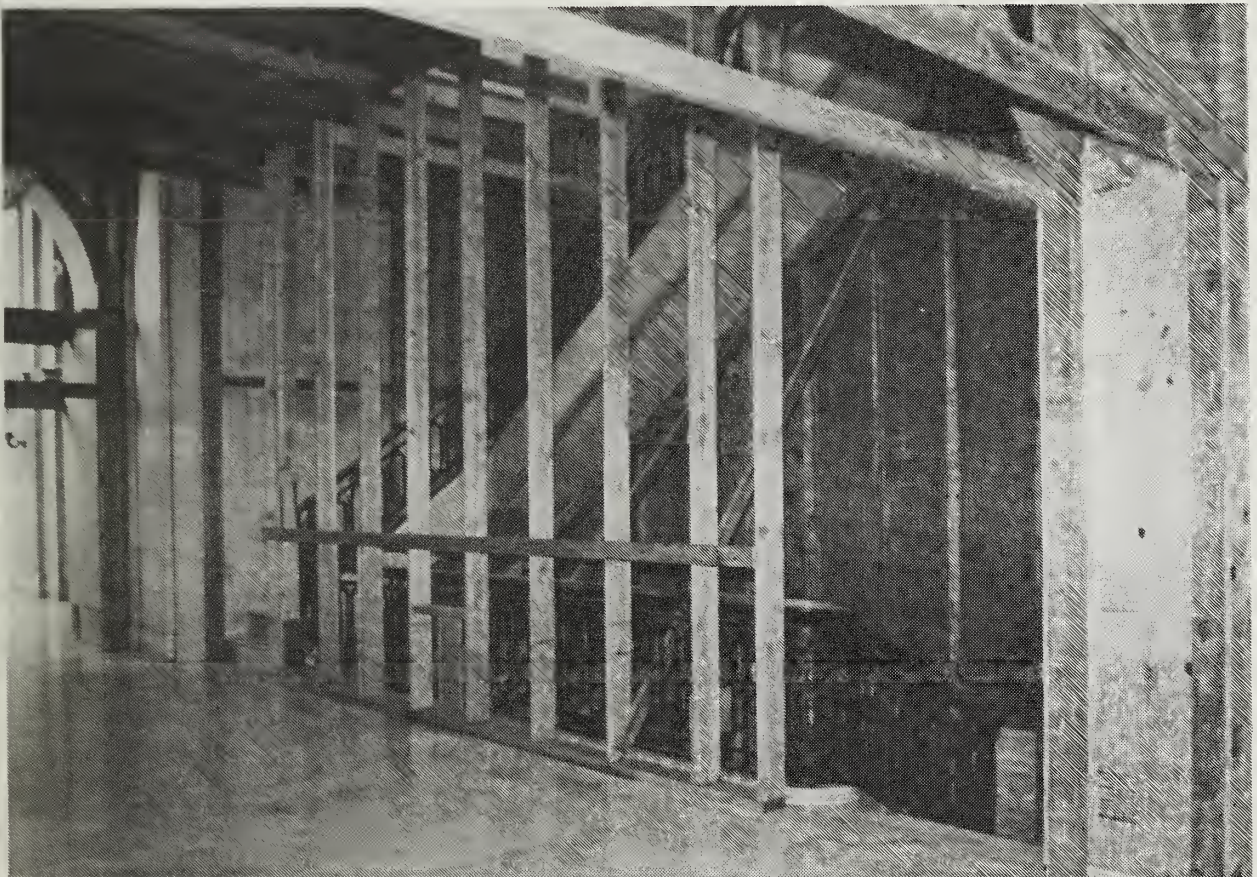
Figure 30 - Stair at Main Stairs

These stairs are intact. Earthquake damage is severe with shoring at stairs S302, S303, and S304 (see figure 30).

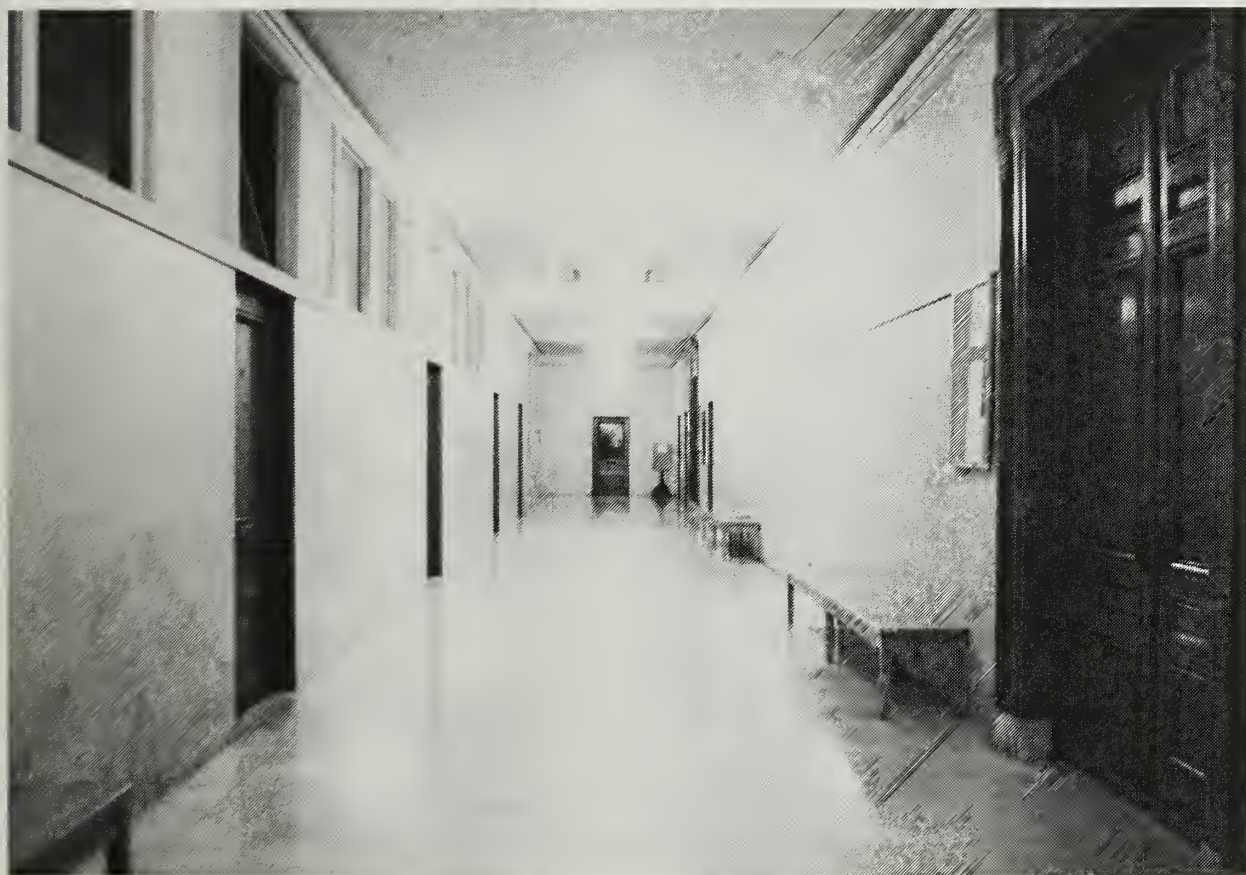
Figure 32 - Fourth floor tertiary corridor

In addition to typical finishes these corridors contain a skylight at the end of each corridor (see figure 32). Plaster damage is evident at skylights, adjacent to the elevator lobbies, and at miscellaneous wall locations. Skylights are soiled and have been covered at corridor C482.
